# **St. Johns Building and Grounds Assessment**

**January 2021**

## **Introduction**

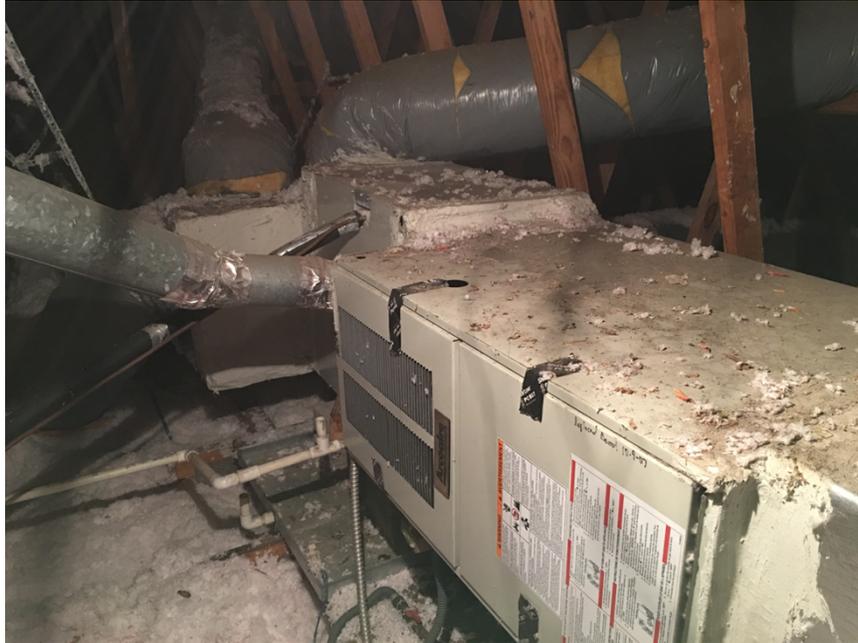
**Parish Hall Attic Air Handling Units**

After each remodel, AC units were added and ductwork added or changed. All of the units are different models, brands, and ages. As a result, the heating and cooling system for the parish hall is “chaotic” as

shown in the photo below. Currently, the system heats and cools adequately but not very efficiently or evenly. The average life of AC units is approximately 12 years and all of the units for the parish hall are older than that so replacement of these units is likely in the near future.

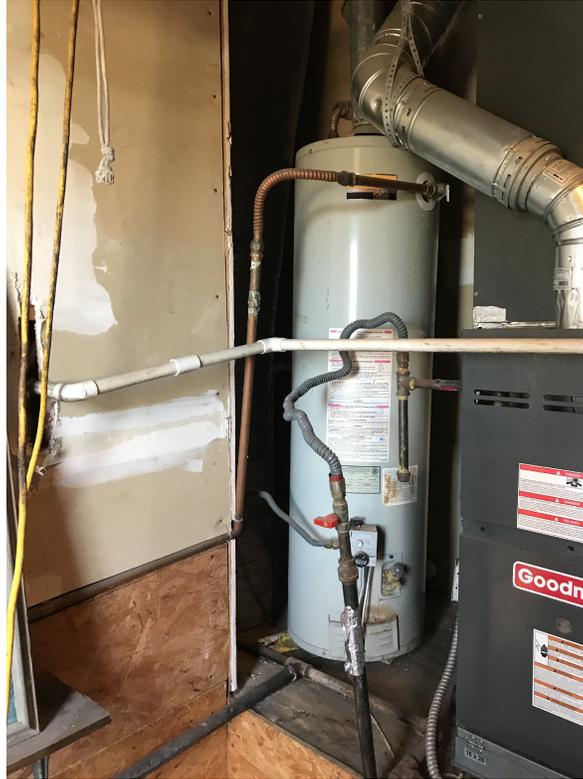
As shown in the photo on the next page, the utility room is so crowded with equipment that it is likely some ductwork and pipes will have to be temporarily removed in order to replace the water heater.

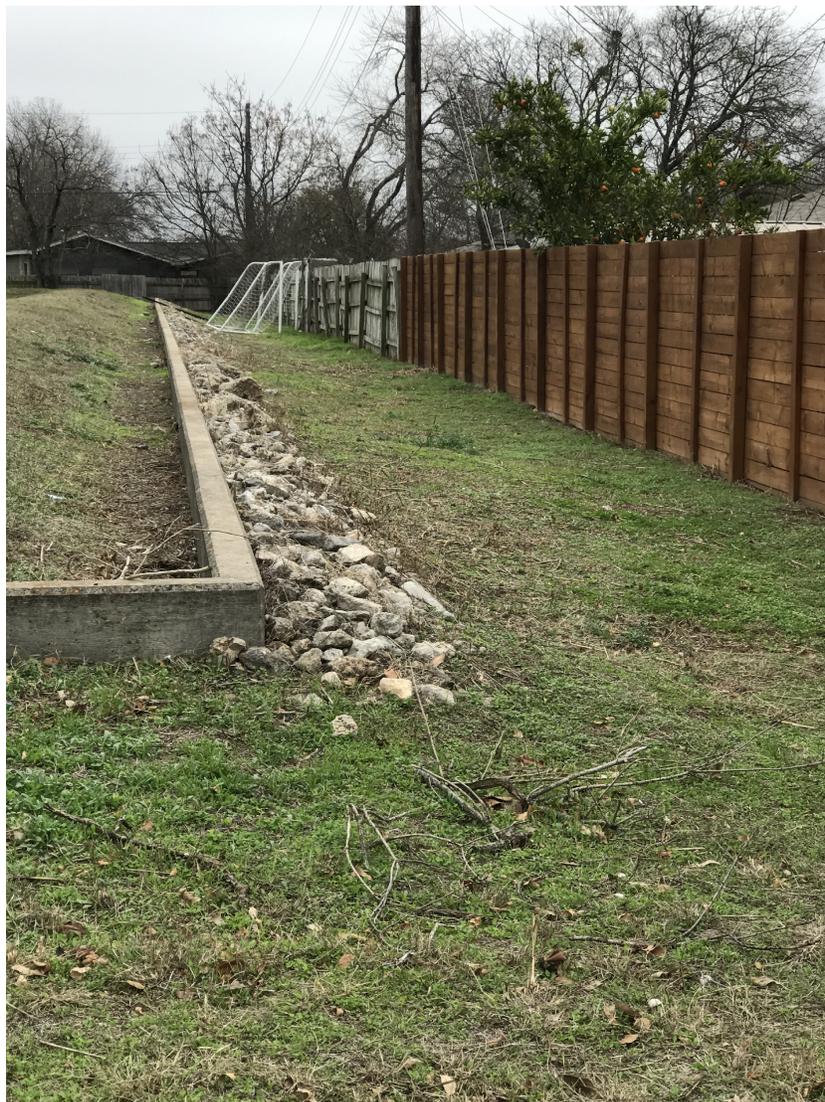
The north side of the property is much higher than the south side. So, when the sanctuary and new parking lot were built is substantially increased the amount of impervious cover and the City required the church to build a berm along a portion of the south side of the property to prevent flooding the neighbors south of the church. The southern third of the property was also designated as a retention pond. As shown on the drawing below, the sides of the berm are steep and dangerous to mow with a riding mower. The south side of the berm is covered with rip-rap and has to be trimmed with string trimmers. Overall, it is a maintenance nightmare.
